Please find enclosed the final removal report for the Youngstrom Log Homes removal action in Blackfoot, Idaho. Removal activities occurred from November 7-21, 1996, and primarily involved the sampling, hazard characterization, and off-site disposal of approximately 1,000 drums and containers consisting of eleven different wastestreams. The site is located at an abandoned log home construction facility situated on the Fort Hall Indian Reservation, and it is believed the containers were brought to the site for disposal by third parties.

# YOUNGSTROM LOG HOMES FINAL REMOVAL ACTION REPORT

**TDD: 96-10-0006**

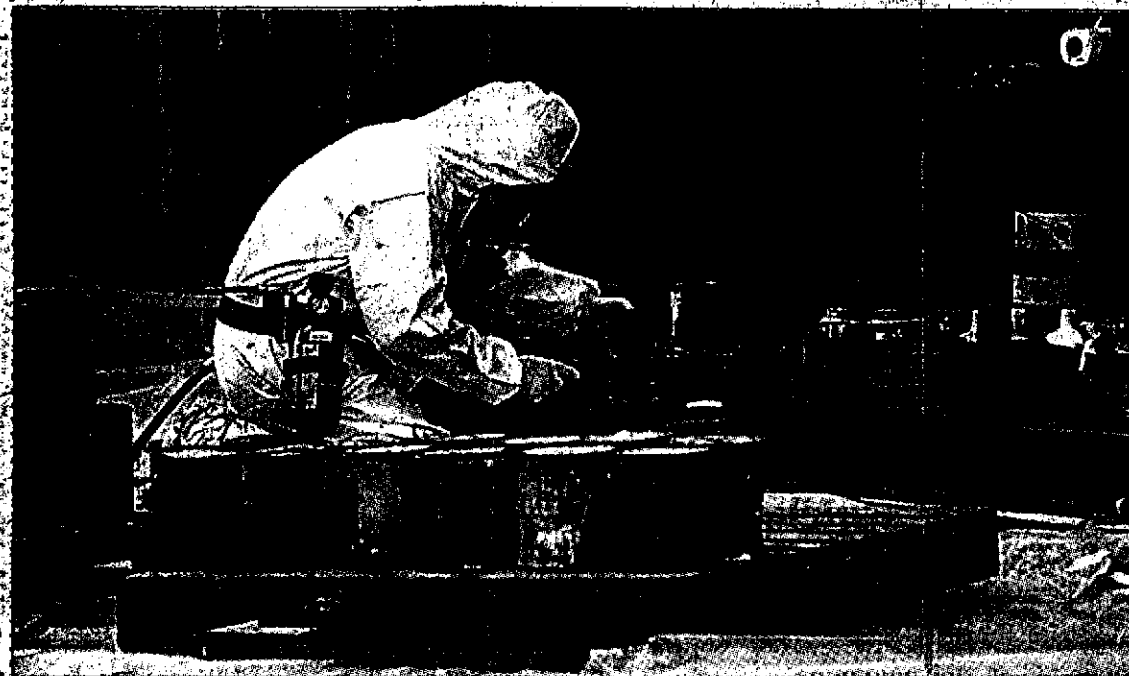
A CET employee contracted by the Environmental Protection Agency looks into rusted cans at the former Youngstrom Log Homes site in Fort Hall.
